# PROBLEM *Solver*<sup>®</sup> BULLETIN

## Rear Inner Toe Link Replacement

2002-2005  
Ford Explorer,  
Mercury Mountaineer  
2003-2005  
Lincoln Aviator

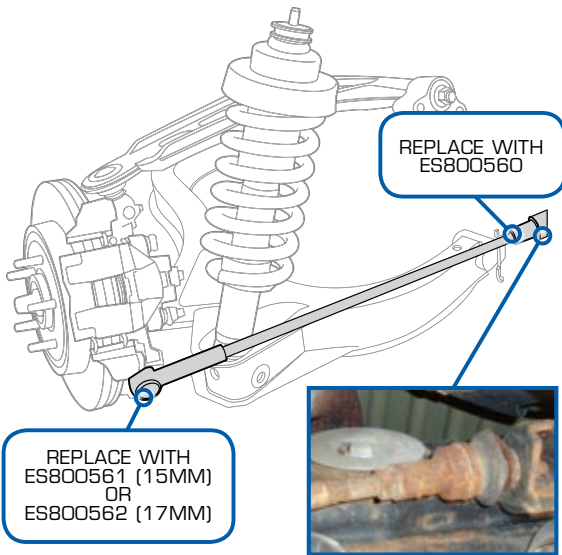
Customers may experience rear end sway, noise and excessive tire wear due to a failed inner toe link. The OE design of the inner toe link experiences excessive wear due to its plastic socket design. Because individual wear components for the affected part are not available at this time, technicians are required to replace the entire rear link (rear knuckle alignment assembly), which is only available from the dealer.

The MOOG<sup>®</sup> ES800560 Rear Inner Toe Link and MOOG ES800561/ES800562 Outer Toe Links are available separately to replace the worn components in the rear knuckle alignment assembly.

These components feature the MOOG exclusive all-metal "gusher" bearing design for exceptional strength and longer life. In addition, the ES800560 is 30% more resistant to socket pull-out, withstanding 15,000 lb. loads versus 11,000-12,000 lbs. for the OE part.
