## BULLETIN

# SWAY BAR LINK FAILURE

2007-2009 MAZDA 3  
2007-2009 MAZDASPEED 3

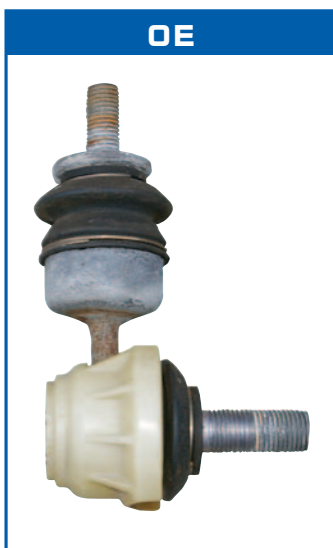
Owners of the popular Mazda 3 may complain of rattling and/or clunking from the rear end of their vehicles. This may be caused by a failed sway bar link.

The OE part is a non-greaseable, plastic socket design and is prone to premature wear. This results in a rattling and clunking noise from the rear of vehicle. Also, the OE replacement part is often damaged during installation: Since wrench flats are not incorporated into the design of the OE replacement part, installers will sometimes use an air wrench to install it. Unfortunately, the friction generated by allowing the stud to spin within the plastic socket may cause irreversible damage.
