PROBLEM *Solver*[™] BULLETIN

Tie Rod End Failures

2001-2004
General Motors
1500/2500/3500 Trucks

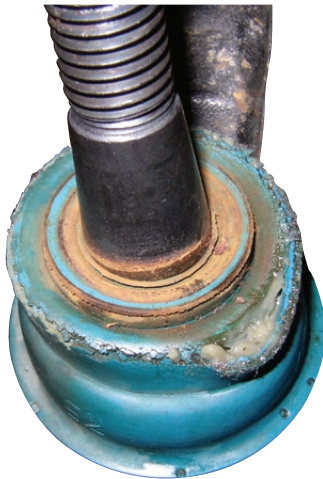
OE tie rod ends failing prematurely due to boot failure

- The boot fails, allowing contaminants and moisture inside. Resulting corrosion and wear cause excessive deflection in the tie rod socket assembly, with loose steering and associated toe angle changes. Tie rods with a non-serviceable polymer socket design are unable to flush the contamination, and corrosion/accelerated wear quickly sets in.
- Boot failure is due to the reduction of carbon black strengthening filler in the polychloroprene material in order to achieve a blue color. Reducing carbon black content cuts material strength, resulting in boot degradation and failure.

SILVERADO 2500HD 2WD
17,613 miles
OE Outer Dust Boot
