PROBLEM *Solver* BULLETIN

Premature Wear of Upper Ball Joint

Dodge Ram 2500/3500 4WD,
Ram 1500 w/Mega Cab

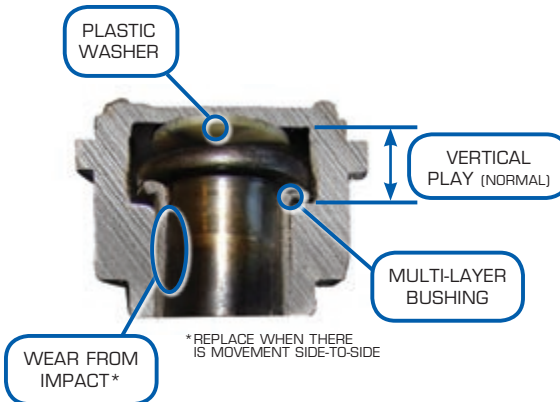
Premature wear of upper ball joint

The installation process puts significant demands on the upper ball joint bowl design. The upper and lower ball joints on these axles may not be perfectly aligned. The OE ball joint design deforms to comply to these demands. This leads to severe wear from impact loads occurring under "normal" driving conditions. The ball joints should be replaced any time there is side-to-side or back-and-forth "radial play" (vertical-only movement is normal).

OE DESIGN IS NON-SERVICEABLE
