PROBLEM *Solver*[®] BULLETIN

Premature Ball Joint Wear

2000-2004 Dodge Dakota
& 2000-2003 Durango

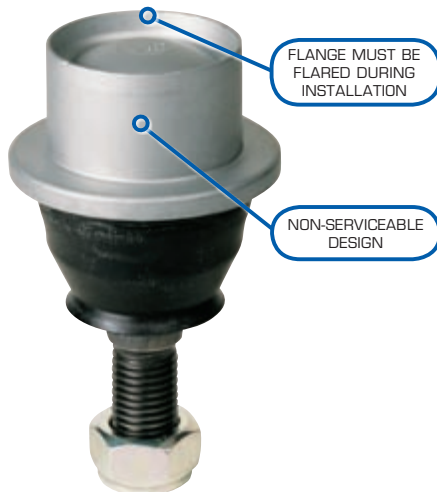
Lower ball joint experiences premature wear

- Non-serviceable polymer sockets cannot flush contamination, which quickly leads to corrosion and wear.
- Stress can quickly erode the polymer load bearing surface.
- OE-style replacement ball joints requires flaring the retention flange during installation.

Be sure to remove old OE-style ball joint flange. It must be bent upward for removal.
