Solver[®]
BULLETIN

Clunking noise from under vehicle

Dodge Dakota and Durango 1997-2004;
Jeep Wrangler 2000-2006

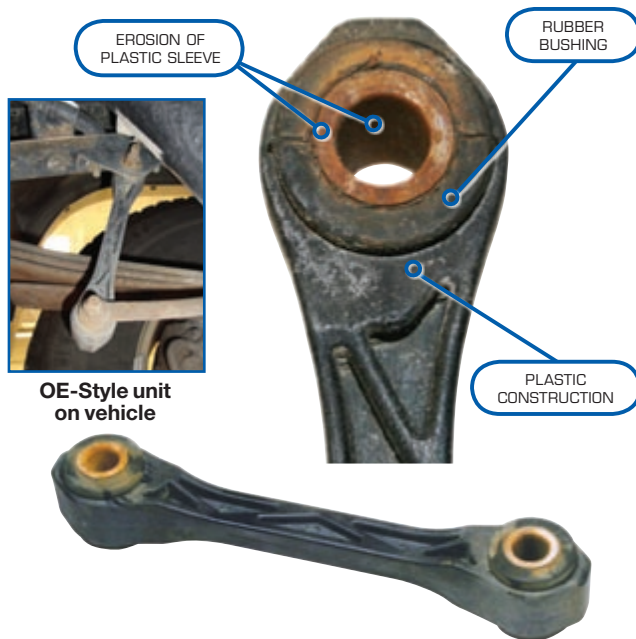
Clunking noise from underneath rear of vehicle

When going over bumps or washboard surfaces, drivers of Jeep Wranglers, Dodge Dakotas and Dodge Durangos may experience clunking and/or banging noise from underneath the rear of the vehicle. The cause is failure of the rear sway bar link. The OE-style link is prone to failure on these vehicles, especially in northern climates where more salt, road grit and grime are present. These contaminants can get into the bushing and erode the plastic sleeve, causing it to elongate and become loose, which creates noise.
