MOOG
 STEERING & SUSPENSION

THE PROBLEM SOLVER®
**LOWER
MOUNTING
HARDWARE**

PROBLEM:
**Rusted Or Stripped
Lower Strut Mounting Bolts**

SOLUTION:
**O.E. Equivalent Lower Mounting
Hardware Included**

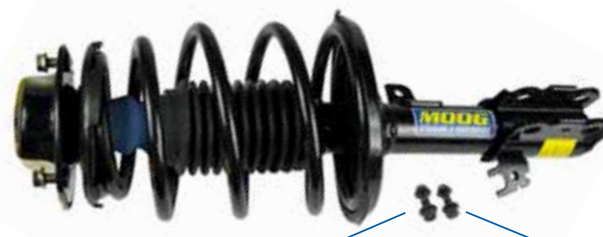
LOWER STRUT
MOUNTING BOLTS

Many MOOG® complete strut assemblies include lower mounting hardware such as strut mount bolts or pinch bolts.

This supplied hardware meets OE specification, and combined with the MOOG complete strut assembly, provides ease of installation and a thorough repair.

Vehicle age and/or environmental conditions can cause the lower strut mounting bolts to be rusted and difficult to remove. During the removal process, the bolt heads may become stripped; the nut or bolt heads may become rounded. If this occurs, they will need to be replaced. This may slow down the repair job, as sourcing new hardware may be time-consuming.
