PROBLEM *Solver*[®] BULLETIN

Hub ABS Sensor Ring and Harness

2004-2008
Chevrolet Colorado/
GMC Canyon

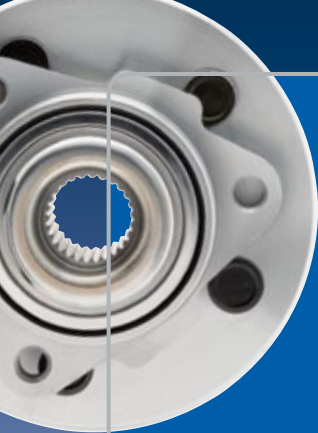
OE Dealer Design

SENSOR
RING AND
HARNESS SOLD
SEPARATELY

The replacement hub assemblies that OE dealerships provide for the affected vehicles do not include a sensor ring and/or harness. This creates the potential for an incomplete repair: A frequent cause of hub replacement is the ABS signal not being “read” properly by the sensor’s input/output. (Replacing the hub assembly alone will not correct this error.) A technician who discovers this during the repair must return to the dealership to purchase a new ABS sensor ring and harness assembly. A technician who chooses to reuse the old one is risking a customer comeback, as it is difficult to remove and replace the original sensor ring and harness without potentially causing ABS sensor failure.

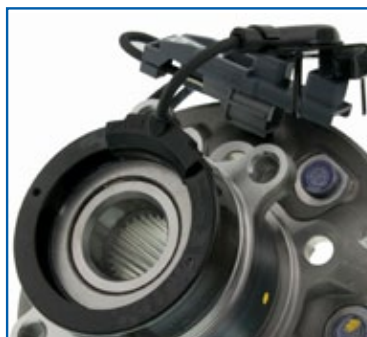
For applications that require it, MOOG hub assemblies include a sensor ring and harness connector.

The MOOG solution for the affected vehicles enables technicians to ensure a complete repair. MOOG provides a complete, OE specification hub assembly that includes a new, pre-attached ABS sensor ring and harness connector. The MOOG Problem Solver design eliminates ABS sensor issues and the need to reconnect the “old” sensor ring and harness to the new assembly. It also prevents future issues that might occur from re-using the old sensor ring and harness, which may not be sending/receiving the ABS signal to/from the hub assembly.
