Solver[®]
BULLETIN

Rear Suspension Pivot Bushing Failure

GM Crossovers
and Minivans

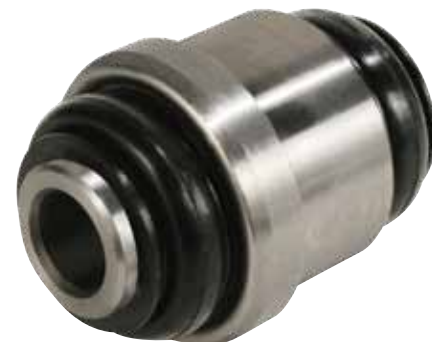
MOOG K200175 lower pivot bushing

The MOOG K200174 and MOOG K200175 pivot bushings correct the looseness and restore alignment integrity. The lower pivot bushing K200175 is a companion part suggested to be changed when the upper pivot bushing is replaced. Since these parts are available separately, the OE axle/hub carrier (knuckle) can be retained.
