PROBLEM SOLVER[®] BULLETIN

UNIVERSAL JOINT FAILURE

2003-2006
JEEP WRANGLER RUBICON

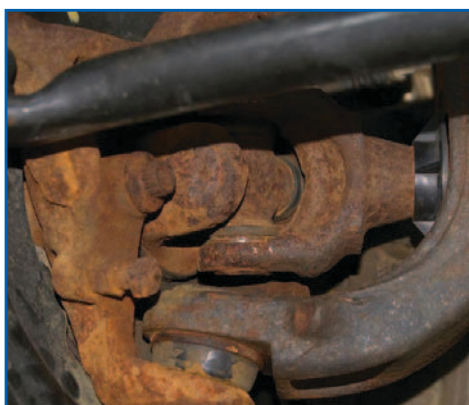
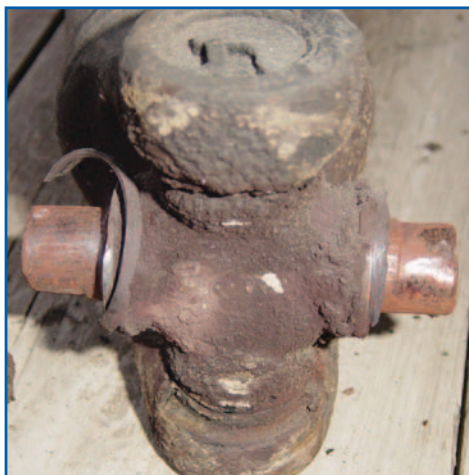
Universal joint can break or seize up

Owners of the trail-ready Jeep Wrangler Rubicon may suffer from driveline failures (universal joints breaking or seizing and excessive corrosion) at the wheel end or driveshaft or axle. Since owners of these vehicles often take them off-road they may be interested in upgrading their driveline to a stronger product option.

MOOG[®] Super Strength[™] Greaseable Universal Joints mounted at the axles and driveshaft are recommended for Jeep Wranglers that may be taken off-road. These u-joints are designed to handle high torque and stress, and their greaseable design allows fresh lubrication to reach critical areas and enables the flushing of contamination. In addition, the MICRO SHIELD[™] coating helps protect against rust and corrosion.
